Macaulay Salmon Hatchery Report

Board of Directors Meeting – April 13, 2024

Incident Timeline

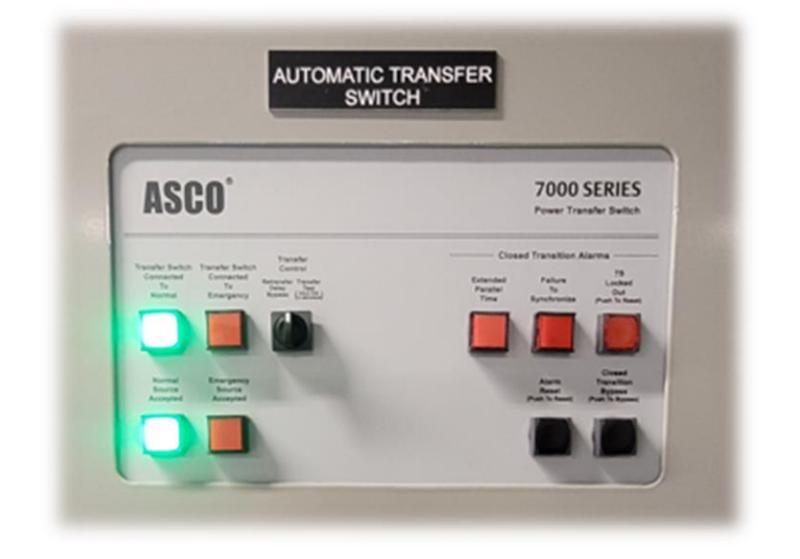
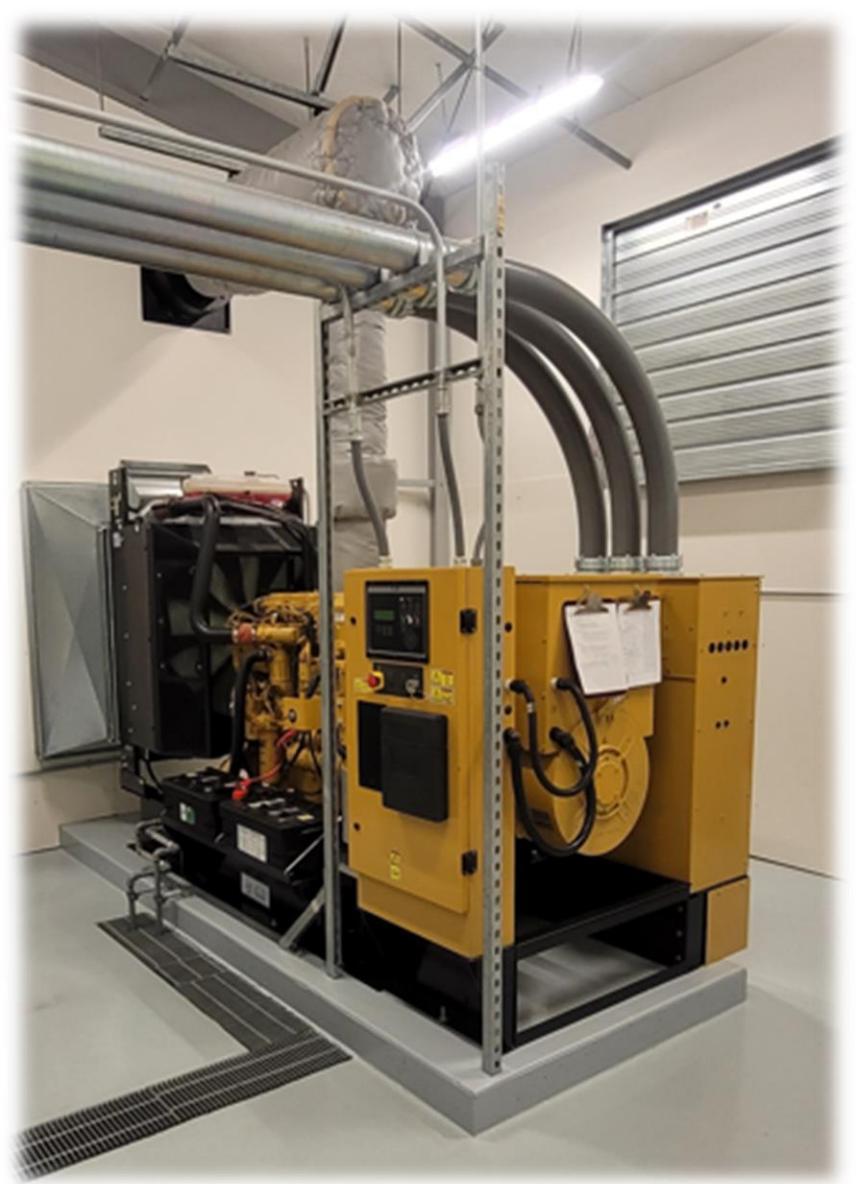
- MSH powered normally by AEL&P
- Backup 250KW diesel generator
- ASCO automatic transfer switch (ATS)

Left: ASCO ATS Top: MSH backup generator

- After 20 minutes into the AEL&P outage, all power was lost at MSH and the site went dark
- Generator room was noticeably hot, so doors were opened to the generator room to allow air flow
- On site staff alerted Manager and Maint. Supervisor and the Maint. Supervisor responded to site
- Generator was found in thermal overload protection
- Louvers to allow air across radiator was found in the closed position due to a loose set screw

- Updated PLC alarm system with more data inputs and alarm set points
 - Generator information with high temp alarm set points
 - Louver position indicators
 - Off site remote monitoring for managers
- Diesel powered pumps for alternate water input from pond
 - Increased redundancy

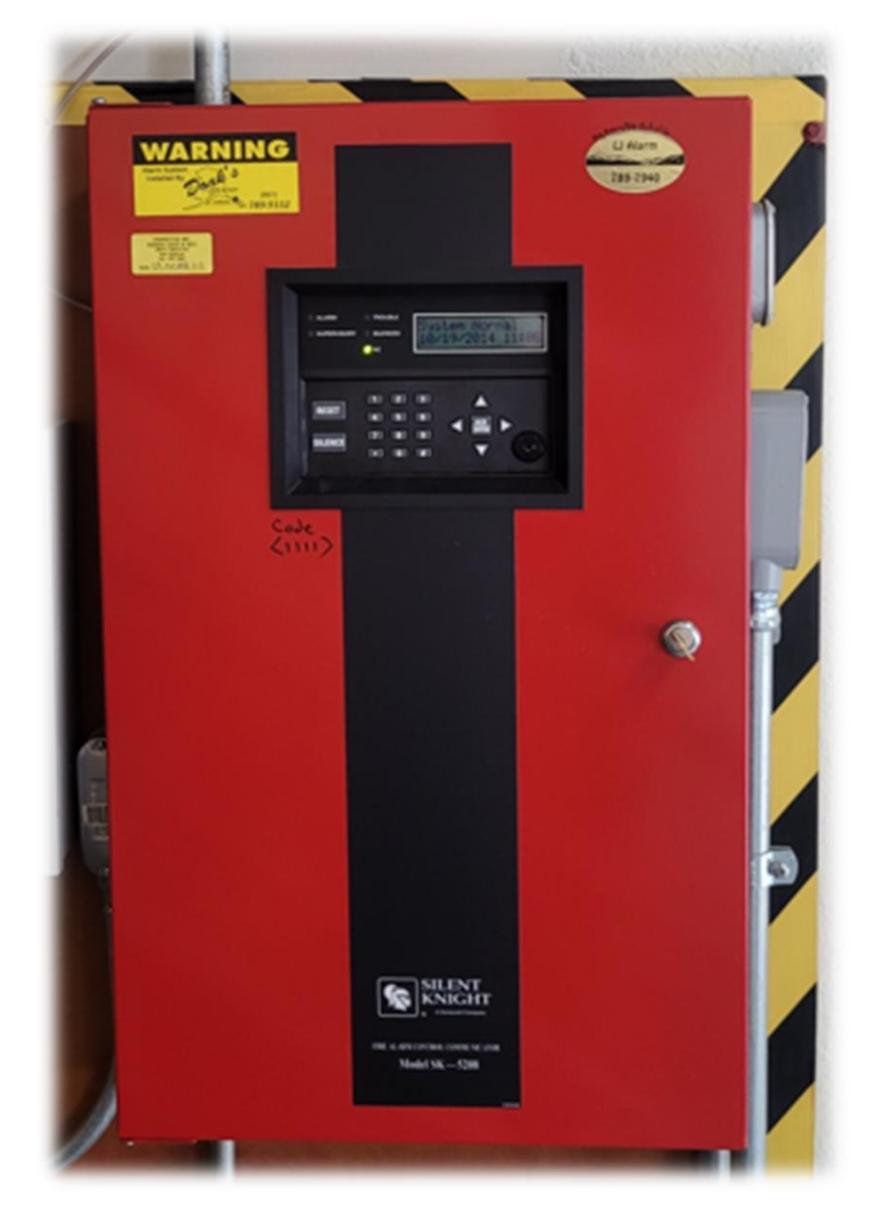
Current Alarm Dialer to LJ Alarms

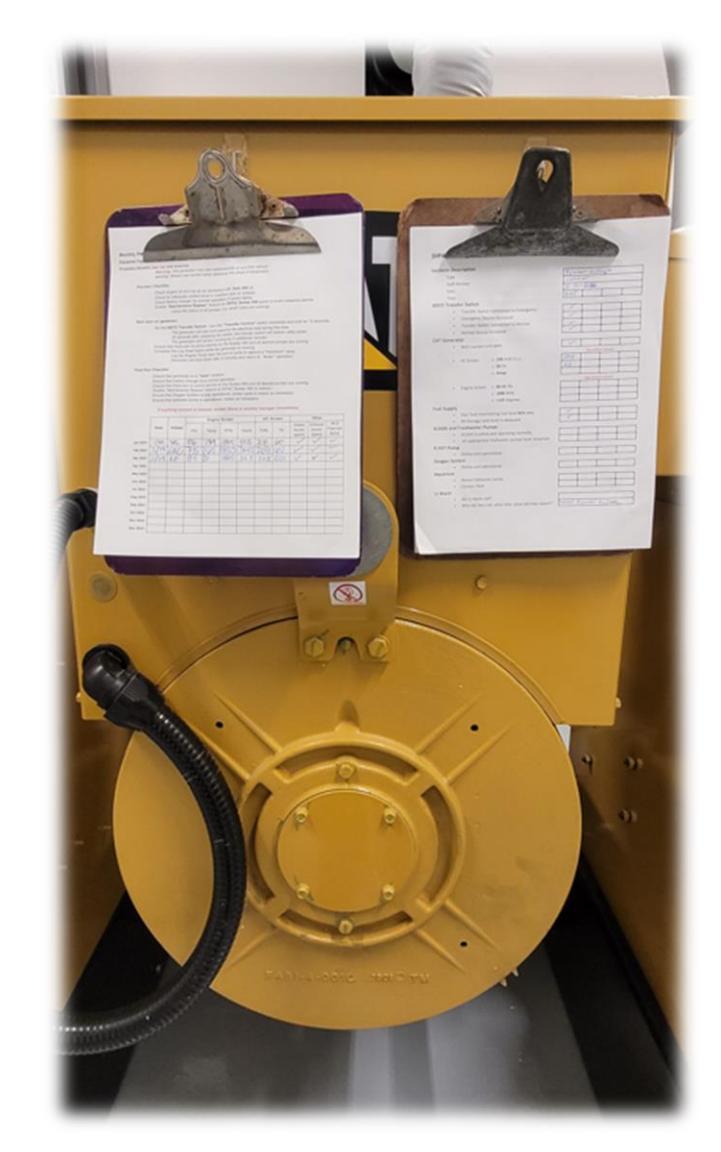
Checklists for monthly run tests and emergency monitoring

- Longer monthly tests running off generator
- Better monitoring during power outages of power generation
- Training more staff on the power generation system & keeping up with frequent trainings
