Macaulay Salmon Hatchery Report

Board of Directors Meeting – April 13, 2024

Incident Timeline

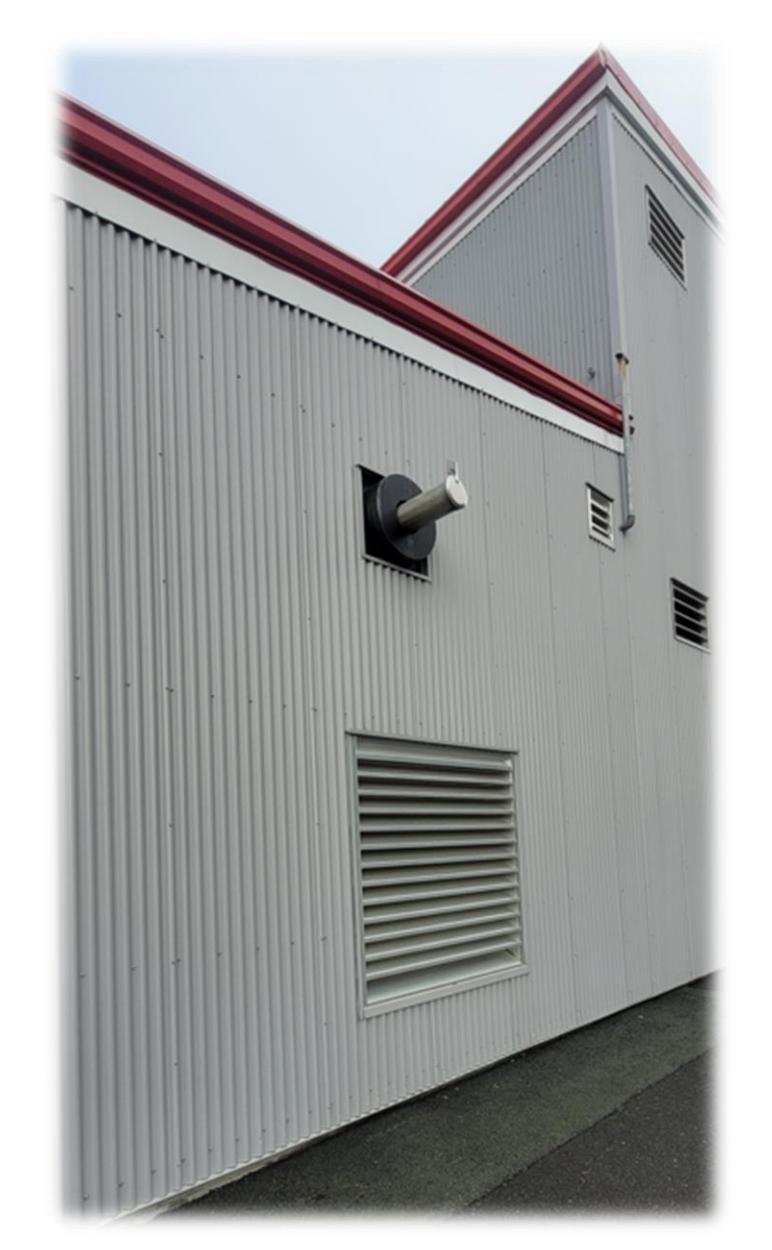
- After 20 minutes into the AEL&P outage, all power was lost at MSH and the site went dark
- Generator room was noticeably hot, so doors were opened to the generator room to allow air flow
- On site staff alerted Manager and Maint. Supervisor and the Maint. Supervisor responded to site
- Generator was found in thermal overload protection
- Louvers to allow air across radiator was found in the closed position due to a loose set screw

- Louvers were manually opened
- Generator was restarted however no power still to site
- ATS tripped between S1 AEL&P position and S2 Generator
- ATS was manually cycled to the S2 position and generator fired up again
- Power was restored to MSH and water started flowing again
- Total time with no water ~45 minutes

- Fish were checked again with main concern being chum incubation
- Dissolved oxygen readings 0-1 mg/L as water started flowing
- Had some immediate fallout the next morning of impacted chum
- Following days thorough incubation checks were conducted
- Chum were sent in to Pathology for a condition report
- Concern of future developmental issues and SW transition loss

- Longer monthly tests running off generator
- Better monitoring during power outages of power generation
- Training more staff on the power generation system & keeping up with frequent trainings
